# TSIYI' TÓ EROSION CONTROL PILOT PROJECT

TÓ NIZHÓNÍ ANÍ  
 TSIYI' TÓ  
 EROSION CONTROL PILOT  
 PROJECT

PROJECT NUMBER:  
 24-457AZ

CONCEPT  
 RESTORATION  
 PLANS

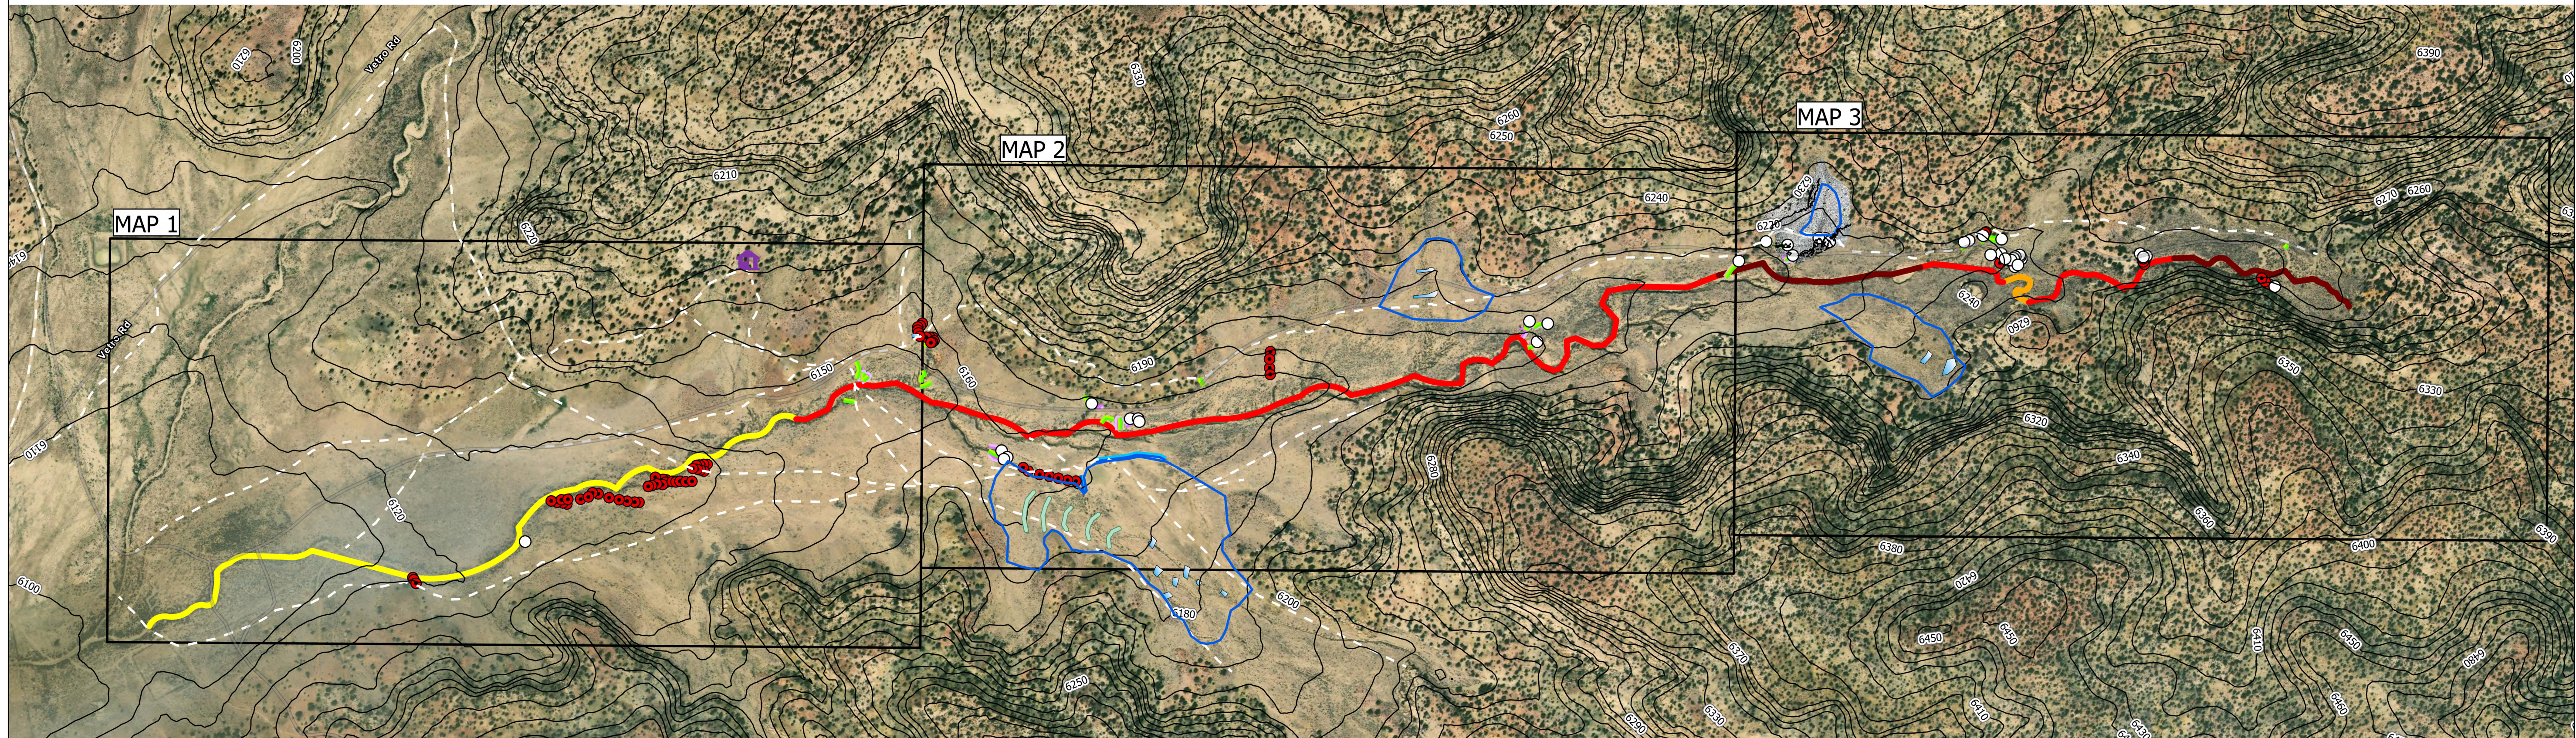
SHEET NAME: OVERVIEW

Structure locations are approximate and symbols are not drawn to map scale.  
 Structures are built from natural materials and will require field fitting depending on materials and site conditions.
